Manhole Inspection Summary

Manhole # S39E__043MH

Insp Date: **8/20/08 3:28 PM**

Location Address: **e fayette st**

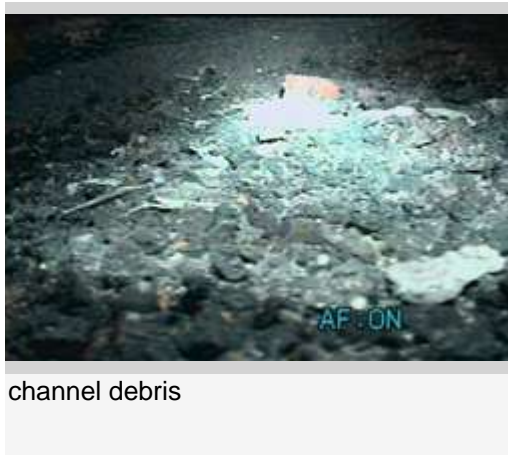
Defect 5

Condition: ☐ Sound ☐ Cracked ☐ Root Intrusion ☐ Deteriorated ☐ Leaks ☒ **Debris**

channel debris

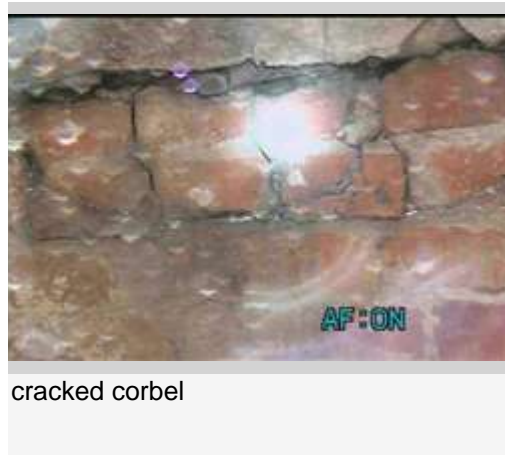
Defect 4

Condition: ☐ Sound ☒ **Cracked** ☐ Root Intrusion ☐ Loose Brick ☐ Deteriorated

cracked corbel

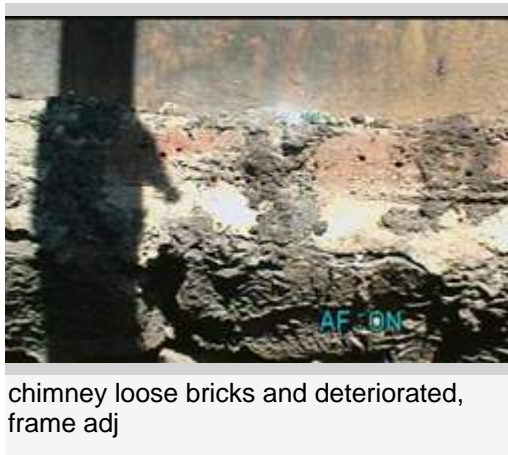
Defect 3

Condition: ☐ Sound ☐ Cracked ☐ Root Intrusion ☒ **Loose Brick** ☒ **Deteriorated**

chimney loose bricks and deteriorated,
frame adj

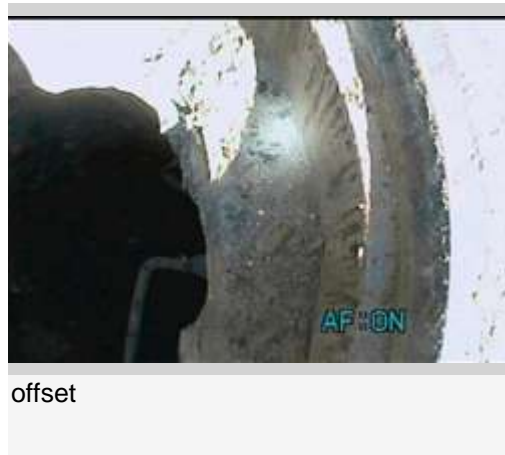
Defect 2

Frame Offset: **3.5** (in.) Condition: ☒ Sound ☐ Cracked ☐ Leaks

offset

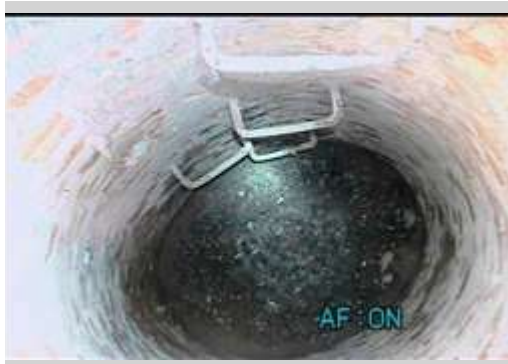
Defect 1

Steps Count: **5** Missing: **1** ☒ **Corroded**

corroded steps, channel debris

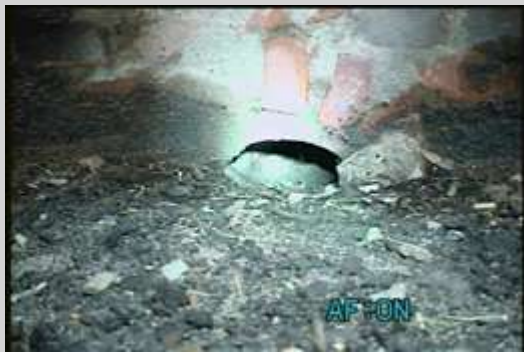
12 O'Clock Outflow

Deposits: ☐ None ☐ Mud ☐ Sludge ☒ **Debris** ☐ Grease

Silt Depth: 6 (in.) Deposits Extent: **Heavy**

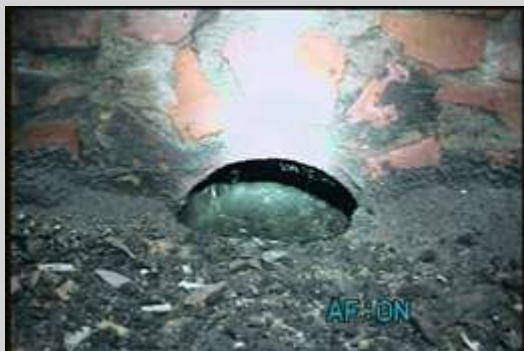
6 O'Clock Inflow

Deposits: ☐ None ☐ Mud ☐ Sludge ☒ **Debris** ☐ Grease

Silt Depth: 4 (in.) Deposits Extent: **Medium**
